**Hogan Asphalt Limited**

**Hendre Mine, The Nant, Rhydymwyn, Mold CH7 5QD**

**Structural Inspection**

**Inspection Report for Planning Application Support**

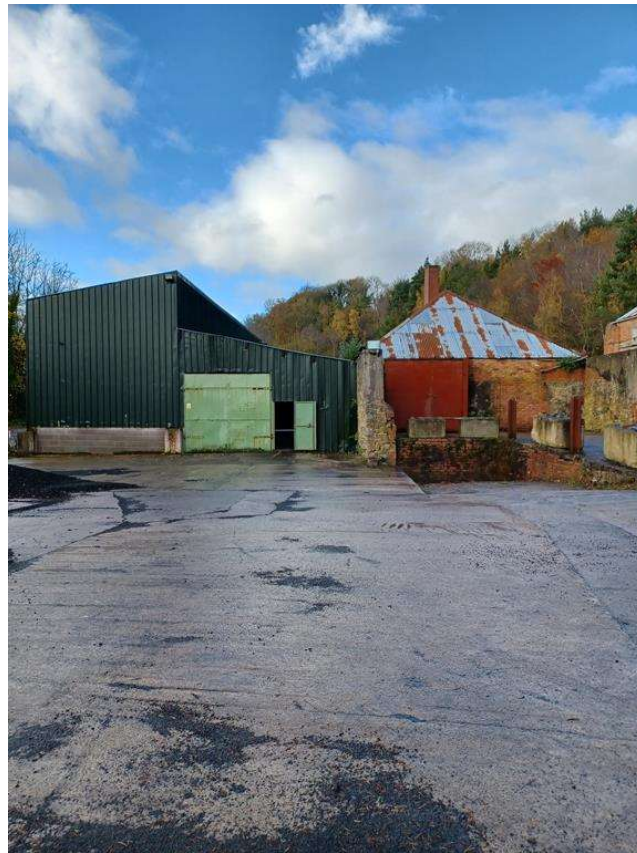
Photos 1 - 10

- 3.1.1 Left hand steel frame structure has vertical profile sheeting
- 3.1.2 Facing blockwork wall at low level to left hand steel frame structure between concrete pads surrounding the steel frame columns

- 3.1.3 Large double door centrally to the steel frame with a single personnel door to the right-hand side. Evidence of impact damage at the door head
- 3.1.4 Stone and brick dividing wall between the steel frame and the brick / masonry section. The dividing wall leans towards the steel frame structure and appears to be in a poor condition

- 3.1.5 Right hand side brick / masonry section of the structure has a large double door
- 3.1.6 Corrugated metal sheet roof appears to be in a poor condition

- 3.1.7 Evidence of bricked up opening to the right hand side
- 3.1.8 Plant growth top left and right-hand corners of the brickwork section
- 3.1.9 Loading bay / ramp to front on right hand side

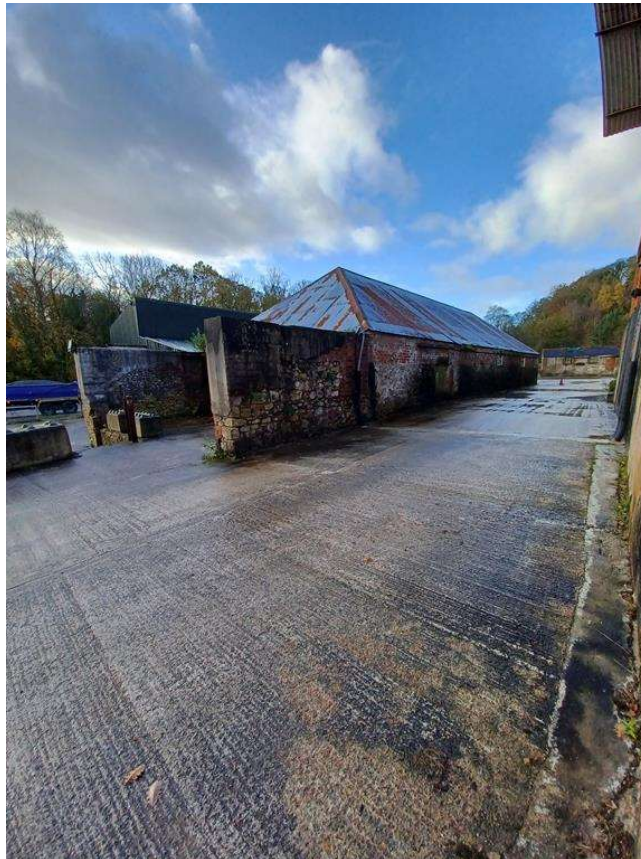
Photos 10 – 19

- 3.2.1 Elevation 2 is along the brick / masonry section of Building A
- 3.2.2 Elevation is a stone masonry wall with 10 courses of brickwork above
- 3.2.3 Timber door towards left hand side with low headroom
- 3.2.4 Two timber framed windows towards the right hand side in poor condition with decayed frames and broken glass
- 3.2.5 Steel corrugated sheet roof appears generally to be in a poor condition
- 3.2.6 Some plant growth through the upper level brickwork
- 3.2.7 When viewed from the side the wall generally appears to be plumb

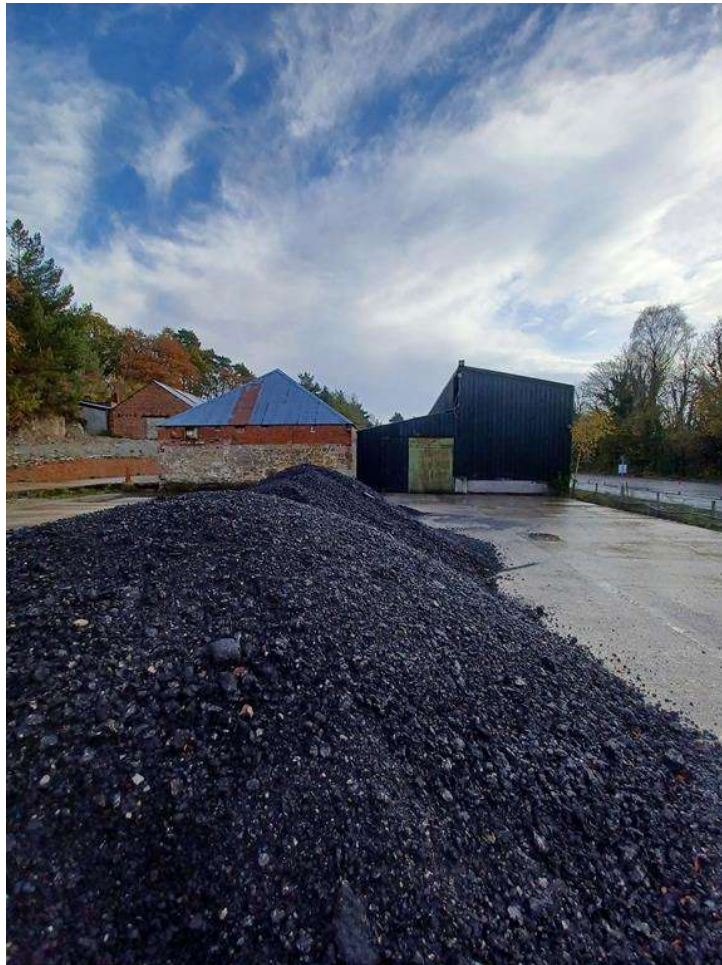
Photo 20 – 28

- 3.3.1 Left hand masonry / brick section of the building has stone wall with brick courses above. Some pockets missing from the brickwork at high level
- 3.3.2 Masonry wall generally appears to be plumb
- 3.3.3 Corrugated metal sheet roof appears to be in a poor condition
- 3.3.4 Right hand side steel frame section of the building has vertical cladding and facing blockwork at low level. Evidence of impact damage to the cladding
- 3.3.5 Large double door towards the left-hand side of the steel frame

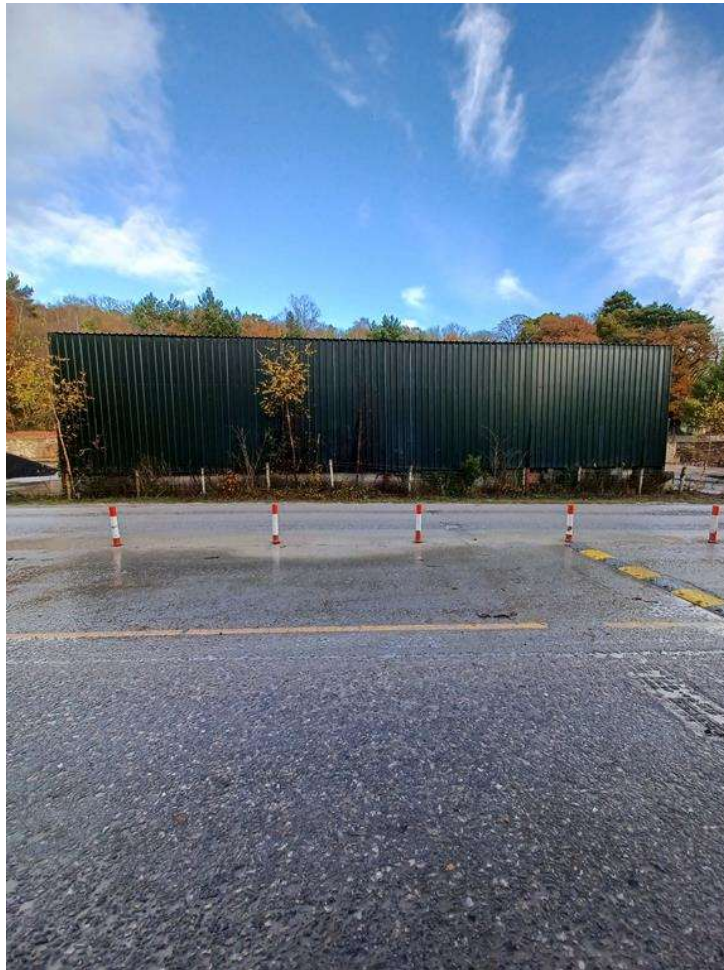
Photos 29 – 35

- 3.4.1 Elevation facing the access road to the adjacent quarry
- 3.4.2 Elevation has vertical profiled metal sheeting with facing blockwork at low level
- 3.4.3 Boundary fence with vegetation growth along the whole elevation

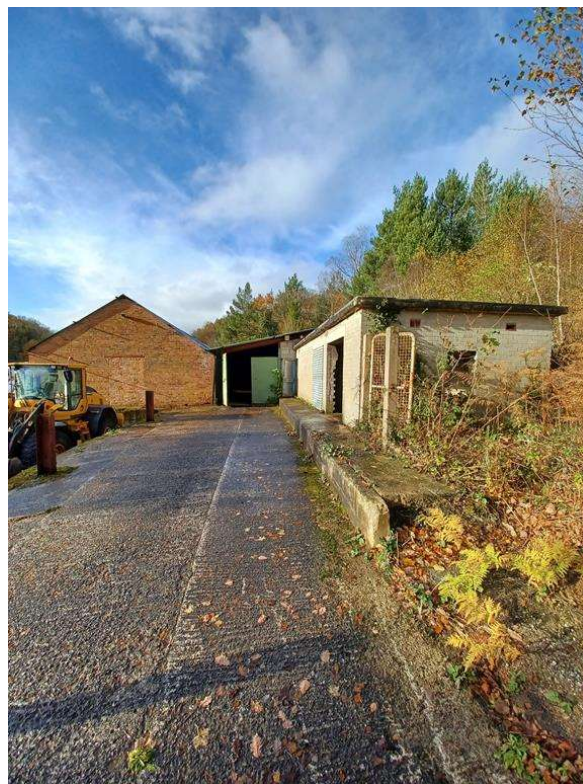
Photos 81 – 99

- 4.1.1 Left hand side is a masonry / brick building (likely to be the original). Right hand side has a steel framed building and attached former electricity transformer building

- 4.1.2 Ground level in this area slopes and steps steeply from left to right upwards
- 4.1.3 Brick gable with mortar pointing to left hand side of elevation with bricked up opening centrally. When viewed from the side the wall appears to be plumb. Headers and stretchers visible indicating 215mm thick solid brickwork wall

- 4.1.4 Concrete retaining walls at low level to the left-hand section
- 4.1.5 Attached transformer building to the right hand side brick built with an in-situ concrete flat roof

- 4.1.6 Diagonal crack bottom right-hand corner of the brickwork gable elevation
- 4.1.7 Damp staining to the top right hand corner of the brickwork gable (likely to be due to run-off from the steel framed roof and lack of rainwater goods)

- 4.1.8 Large double door to the steel frame section of the building
- 4.1.9 Plant growth in wall to the right hand side of the double door

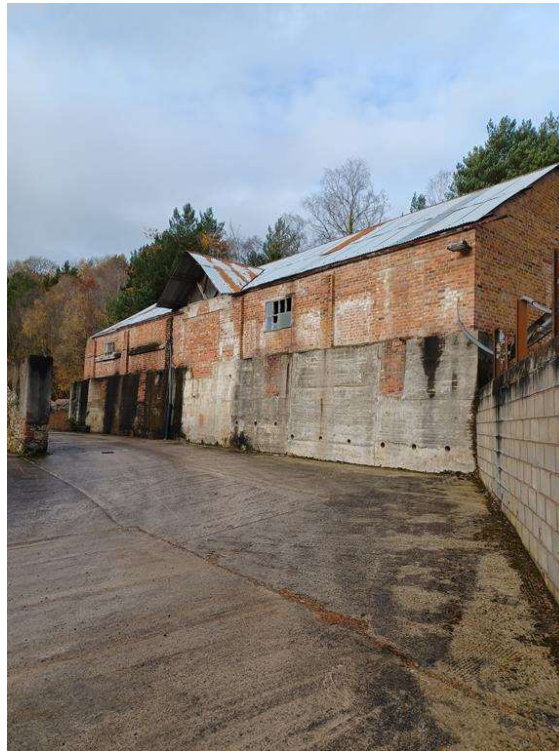
Photos 113 – 138

- 4.2.1 To the right-hand side of the building there is a block faced retaining wall with a storage container positioned above. The retaining wall appears to lean and bulge on the front corner with an extensive stepped crack visible. It is likely that remedial works will be required to this retaining wall

- 4.2.2 Large concrete retaining wall along the lower level of Elevation 2
- 4.2.3 Internal floor level to Building B appears to be approximately at the head of the concrete retaining wall

- 4.2.6 Some openings to the top brick wall have been infilled
- 4.2.7 Weep holes visible in the concrete retaining wall
- 4.2.8 All rainwater goods appear to be in a poor condition

- 4.2.9 Two windows on elevation with timber lintels over. Windows appear to be in a very poor condition and it is likely that the windows and lintels will need replacement

- 4.2.10 Glazed gable peak centrally to the elevation appears to be in poor condition
- 4.2.11 Diagonal cracking in the brickwork below the left-hand side of the gable. Appears to be top left hand corner of a bricked up opening

- 4.2.14 Brickwork wall above the concrete retaining wall appears to possibly lean out towards the top (this could be an optical illusion due to the slope of the concrete retaining wall below). Not possible to measure with a spirit level externally due to height and elevation of wall
- 4.2.15 Regular vertical joints in the concrete retaining wall indicating day joints during construction
- 4.2.16 Generally the corrugated metal sheet roof appears to be in a poor condition
- 4.2.17 Brick retaining wall to the left-hand side of the elevation supporting an access ramp above is in poor condition with an extensive lean out at the top

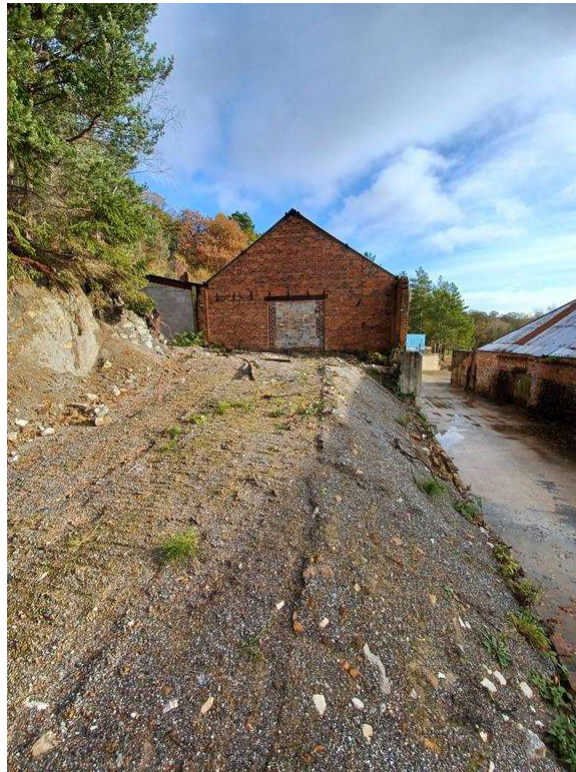
Photo 139 – 152

- 4.3.1 Elevation accessed via a ramp from the rear yard area
- 4.3.2 Brick gable to the right-hand side with a large bricked up opening centrally
- 4.3.3 Facing blockwork to left hand side in steel frame section
- 4.3.4 Appear to be excavations for possible removal of trees and plant growth at the foot of the brick gable
- 4.3.5 Diagonal cracking to top left and right-hand corner of the steel beam above the bricked up opening in the brick gable. To the left hand side the cracking continues horizontally to eaves level at the junction of the brick built building and the steel frame section
- 4.3.6 Step / lateral movement of blockwork at the head of the facing block wall to the steel frame (this could possibly have been original at the time of construction with a reduction in block thickness as mortar is visible at the step)

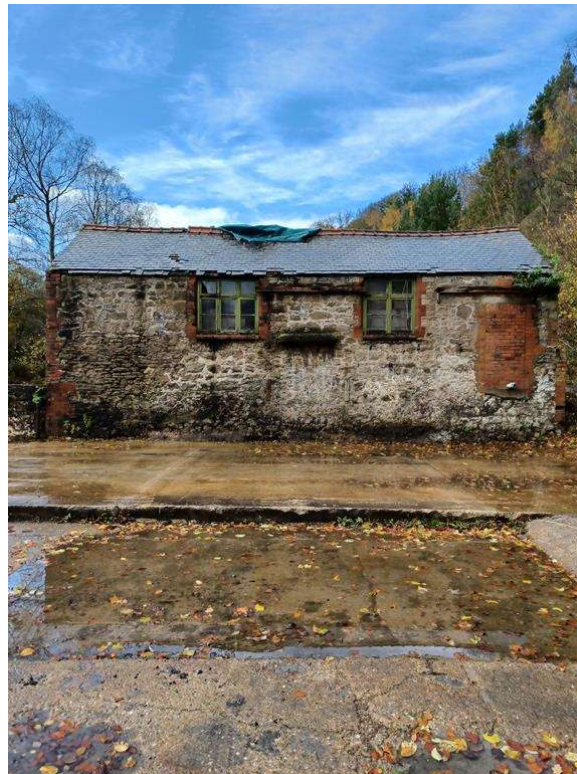
Photos 209 – 223

- 5.1.1 External ground level is lower than internal floor level and it appears that the lower section of the stone elevation is retaining
- 5.1.2 Stone masonry elevation with brickwork to the corners and surrounding the two windows
- 5.1.3 Slate roof in poor condition with extensive undulation of the ridge line. Sheet covering to central part of ridge. Holes visible in slate finishes
- 5.1.4 Plant growth top right hand corner above bricked up former opening. Former opening appears likely to have been a door
- 5.1.5 Timber wall plate with extensive decay visible
- 5.1.6 Wall appears to be plumb when viewed from the sides

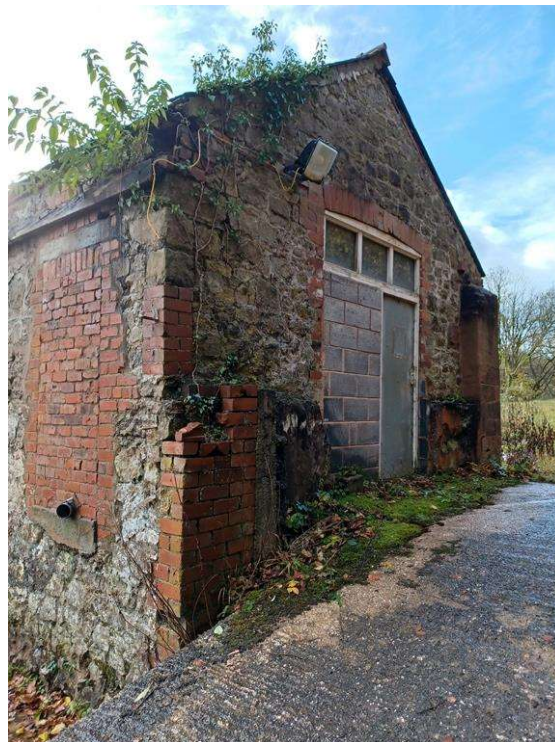
Photos 224 – 230

- 5.2.1 Gable stone elevation
- 5.2.2 Ramp up to side elevation level
- 5.2.3 Blocked up opening with personnel door to the right hand side within the gable
- 5.2.4 Shallow brick arched lintel above blocked up opening with timber framed window
- 5.2.5 Open joints to the stonework on the top left-hand corner with plant growth
- 5.2.6 Block buttress on the corner of Elevation 2 and 3

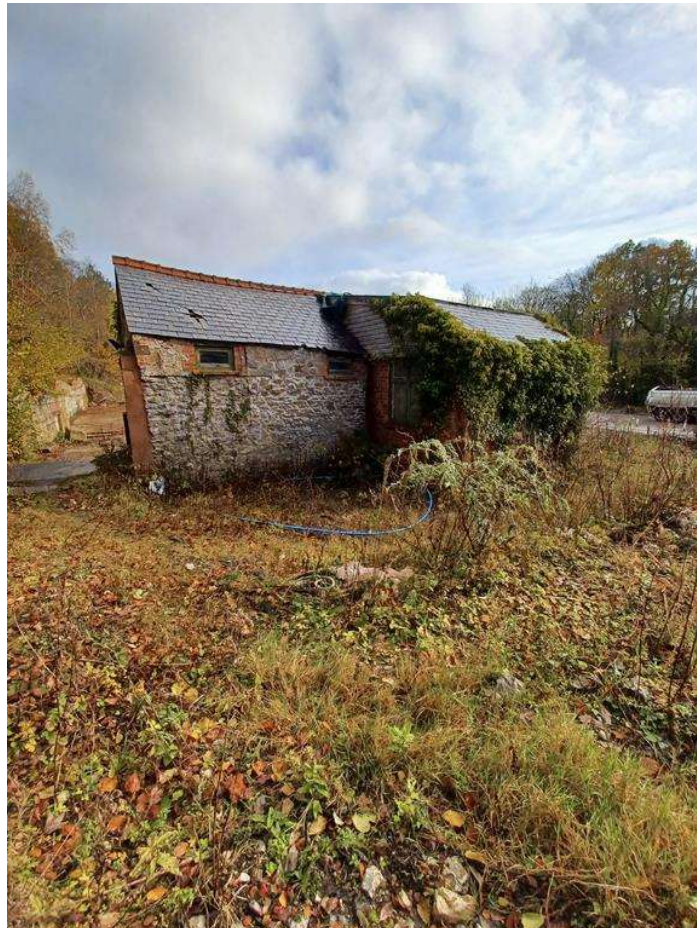
Photo 231 – 242

- 5.3.1 Lean-to extension to Elevation 3 constructed from brickwork. Part pitched slate roof and part felted flat / shallow pitch
- 5.3.2 Lean-to extension has extensive plant growth which restricts inspection
- 5.3.3 All roof generally appears to be in a very poor condition. Holes visible in slate finishes
- 5.3.4 Stone masonry wall to the main elevation appears to be in a satisfactory condition and appears to be plumb when viewed from the sides
- 5.3.5 Timber cladding to the lean to extension decaying at the junction of the slate roof

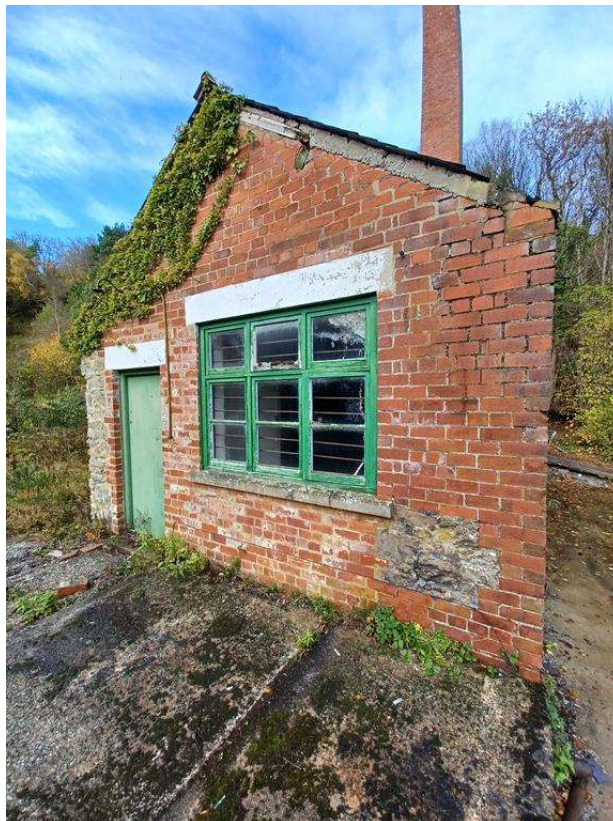
Photos 243 – 246

- 5.4.1 Large timber framed window and personnel door in the brick gable elevation
- 5.4.2 Stonework on corner to Elevation 3
- 5.4.3 Plant growth at high level on gable
- 5.4.4 End of timber purlin visible on the front roof pitch with decay evident
- 5.4.5 Concrete lintels above the two openings appear in reasonable condition
- 5.4.6 Open mortar joints top right hand corner

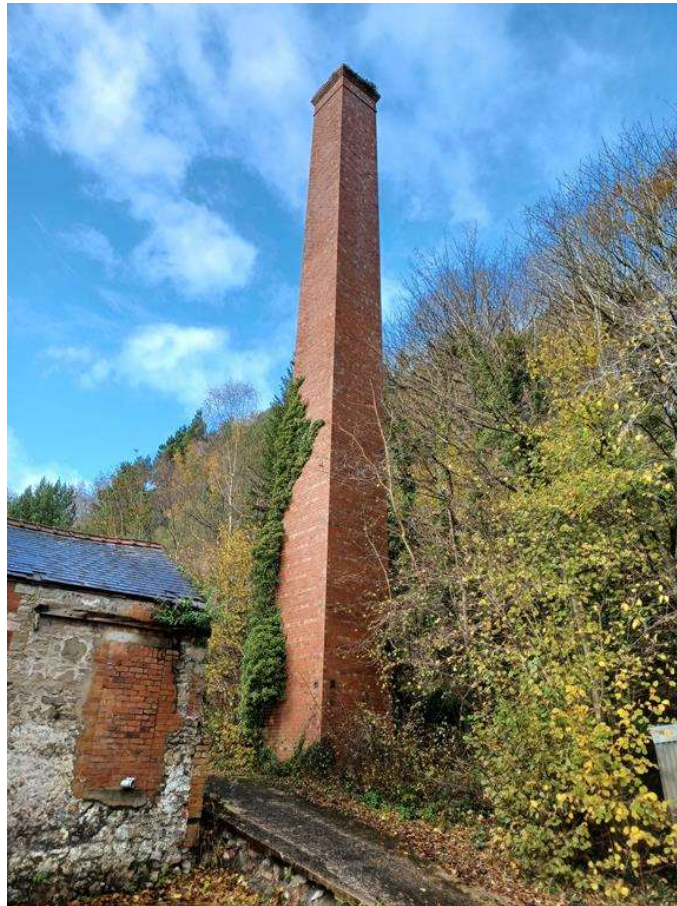
Photos 280 – 319

- 6.1.1 Chimney constructed from red brick with mortar pointing
- 6.1.2 Header and stretcher courses visible for the full height of the chimney indicating possible 215mm thick, or thicker, construction

- 6.1.3 Patress plates visible at approximately 1.8m from ground level. The purpose of the patress plates and tie bars are not clear – there does not appear to be any visible historic movement in the chimney so they may be an original construction feature to “hold together” the brickwork where the bottom opening interrupts the brickwork continuity which could otherwise have led to cracking of the masonry on heating / cooling.

- 6.1.8 Appears to be loose and missing brickwork at the head of the chimney
- 6.1.9 With the exception of 6.1.8 generally the brickwork appears to be in a satisfactory condition with no evidence of cracking or defects
- 6.1.10 Inspection from the woodland side confirms that the patress plate towards the front is missing along with the bolt. The rear patress plate is suffering from extensive corrosion. No evidence of any cracking or bowing to the brickwork at the patress plate locations
- 6.1.11 Slight surface erosion of the brickwork above the ground level arched opening

- 6.6.1 It is proposed to retain the chimney on the site if possible.
- 6.6.2 Generally the brickwork visually appears to be in a satisfactory condition with no visual evidence of any significant structural defects noted.
- 6.6.3 We recommend that a high level inspection is carried out as there does appear to be missing / loose brickwork and plant growth.

All plant growth should be removed, and the loose / missing high level brickwork repaired.

- 6.6.4 Consideration should be given to replacement of the patress plates and through bolts as it appears these may have suffered from corrosion to the rear of the chimney.
